# Challenges for the structural engineer on renovation of ancient buildings

Tallinn conference

May 2018

Aris Chatzidakis , civil engineer

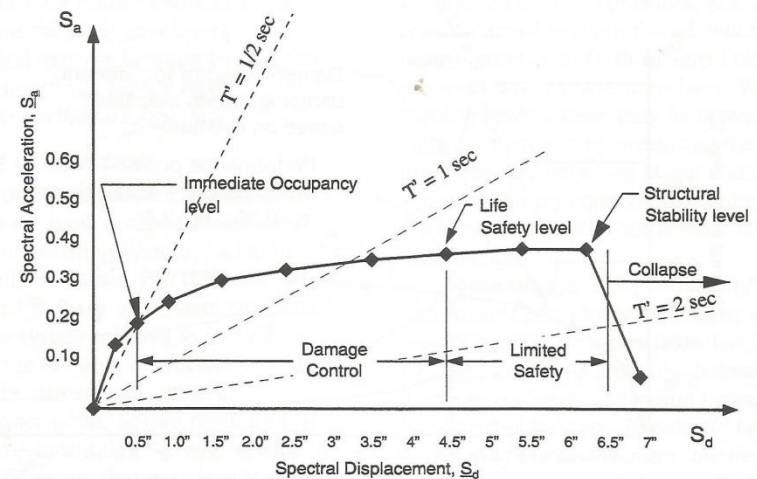
Figure 6-3. Typical Capacity Spectrum

## SEISMIC EVALUATION AND RETROFIT OF CONCRETE BUILDINGS

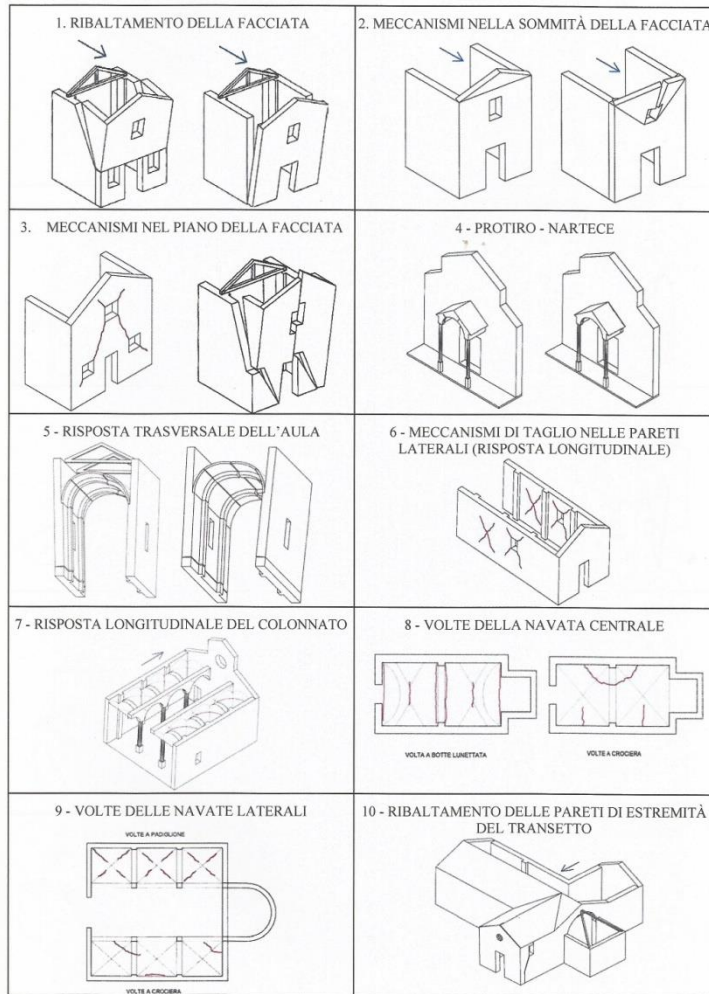
ABACO DEI MECCANISMI DI COLLASSO DELLE CHIESE

# Simplified models based on rigid body equilibrium and cinematic methods upon common failure types

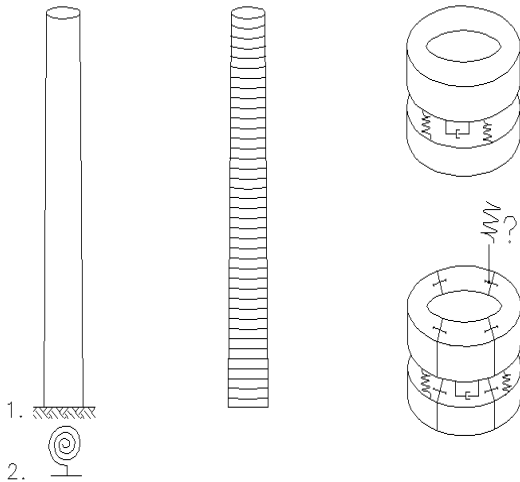
ΔΙΑΦΟΡΕΣ ΜΟΡΦΕΣ ΠΡΟΣΟΜΟΙΩΜΑΤΩΝ

# Mathematical modeling needs reliable data

- Determining the real dynamic response of a historic structure is, at a certain point, a non realistic requirement within the frame of a professional occupation with these subjects.
- We often feel that we perform sophisticated calculations with wrong numbers

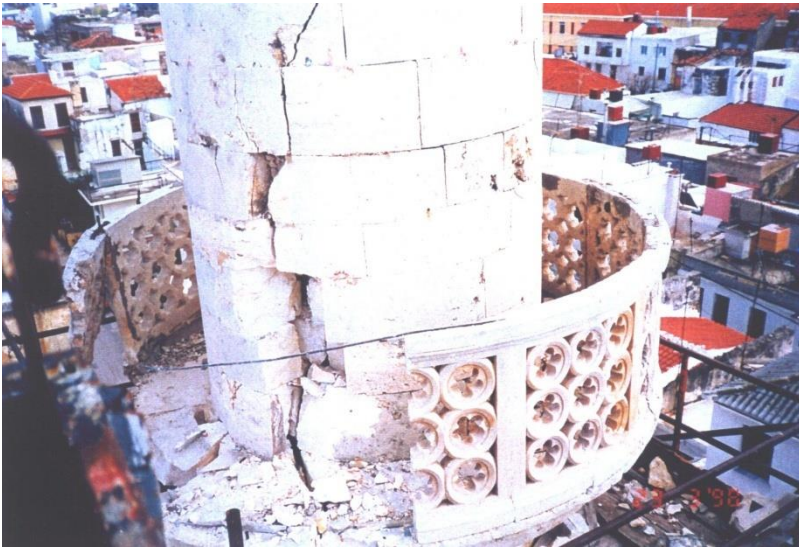
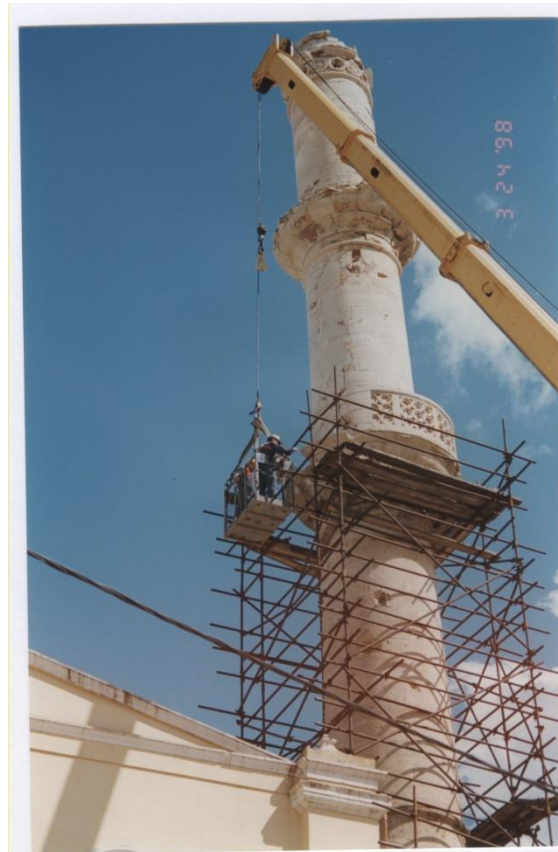
# The Splandzia minaret before restoration works

- Very severe damage and dangerous inclination but yet not collapse

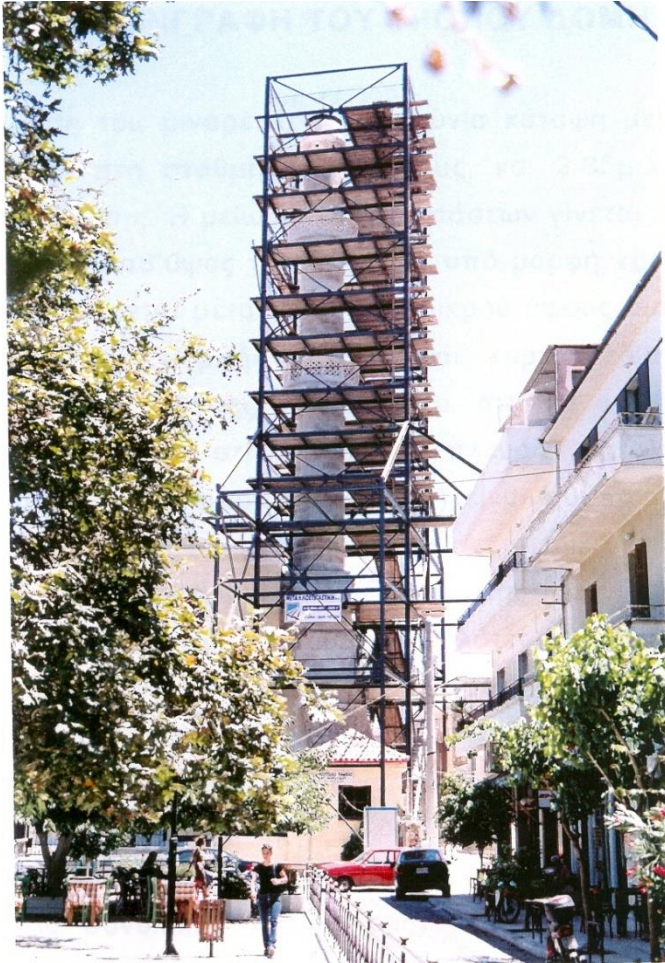
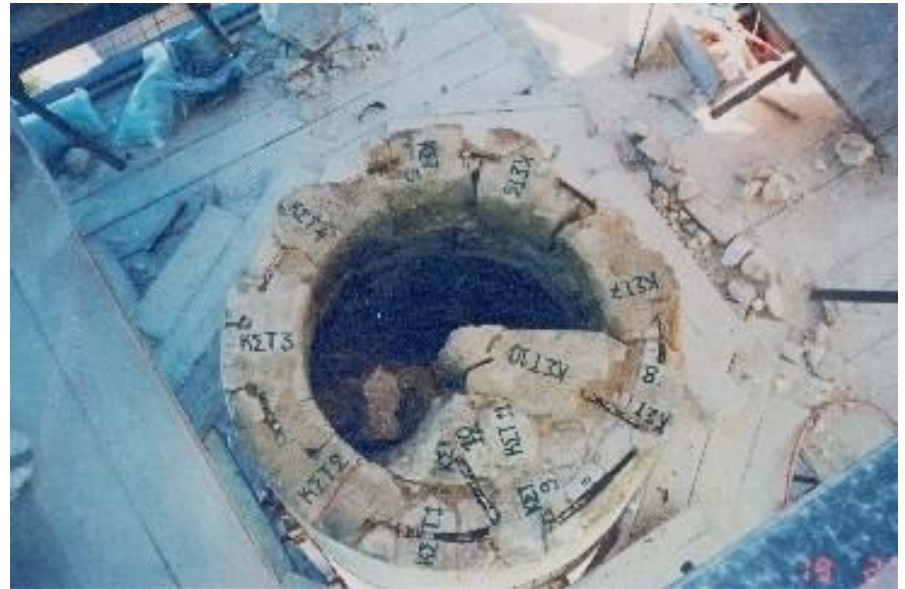
# The retaining and working scaffolding

The construction of the staircase was at first approach incomprehensible. There was no geometric reason for such a complexity. Was it by existing rules of art conceived as an energy dissipating device.?

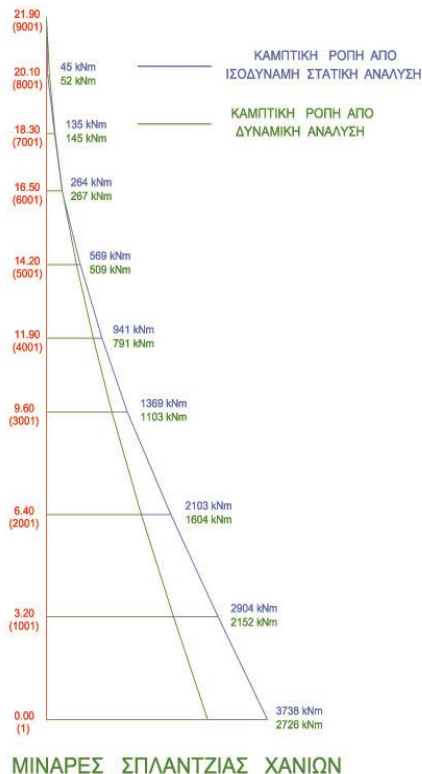
# Analysis data and a very uncertain decision of intervention method

- The seismic analysis of the minaret as a monolithic cylindrical cantilever cannot prove its sufficiency or even its stability according to the current earthquake regulations.
- However, the minaret is in fact a non-monolithic structure, with numerous constitutive elements which are not strongly attached to each other and whose total rigidity is difficult to measure – however, it is certain that it's low. Flexibility is essential for the monument's resistance, since it implies a long natural period of the minaret and, hence, very low rates at the accelerations design spectrum.

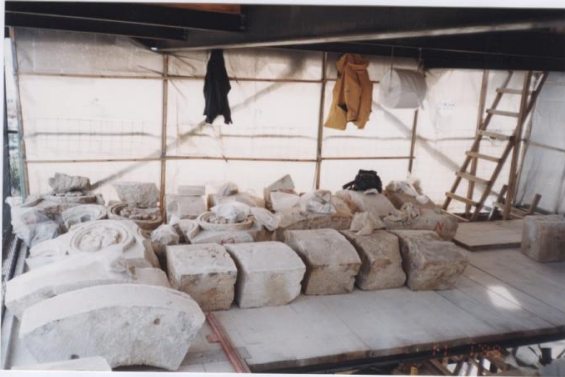
ΣΥΝΤΗΡΗΣΗ  
ΟΙ ΚΑΘΑΡΙΣΜΕΝΕΣ ΠΕΤΡΕΣ ΤΑΞΙΝΟΜΟΥΝΤΑΙ ΜΕ ΤΑ  
ΘΡΑΥΣΜΑΤΑ ΤΟΥΣ ΚΑΙ ΨΕΚΑΖΟΝΤΑΙ ΜΕ ΜΗΚΥΤΟ-  
ΚΤΟΝΟ.

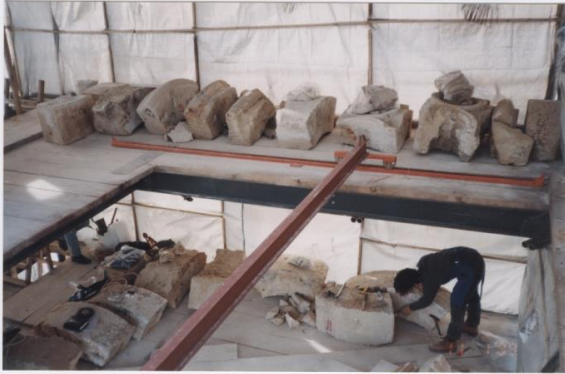
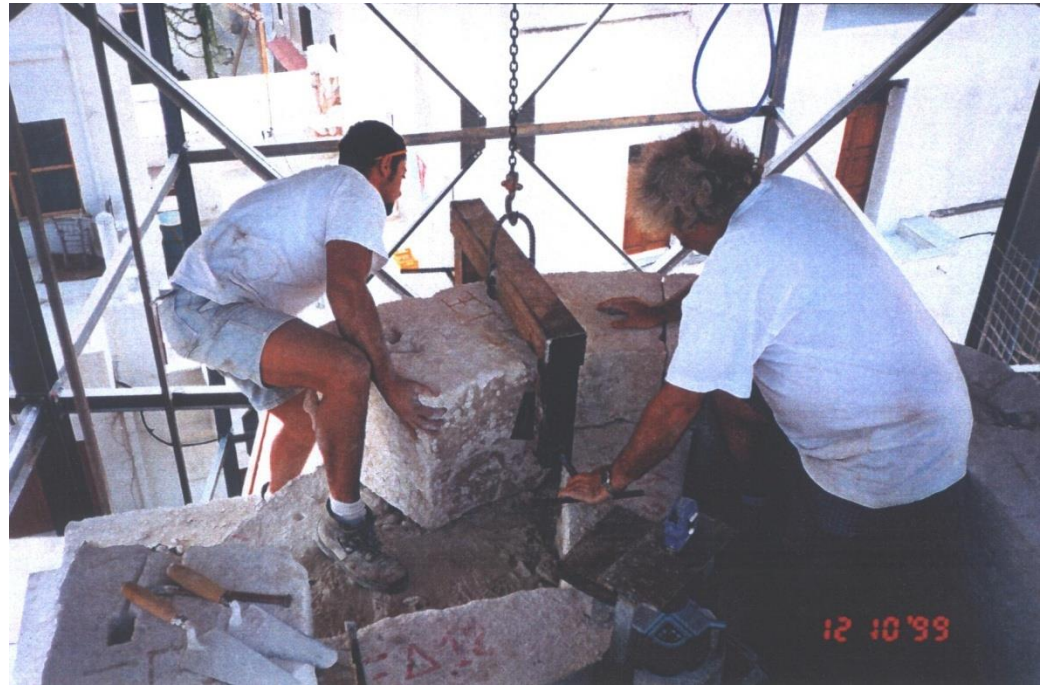
We have respected the construction technology that was revealed to us. Filing with plumb all iron fastenings was essential for the protection and the ductility of connections which allow energy dissipation through plastic deformations

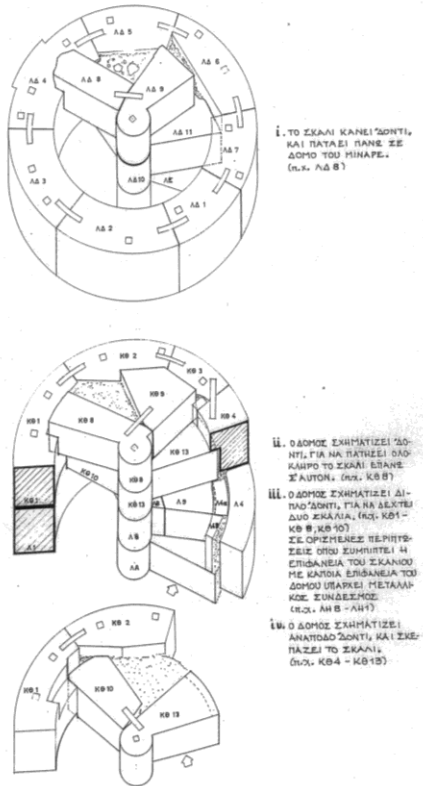
Μολυβδοχύτεση συνδέσμων, οριζόντιων τζινετιών και κατακόρυφων γόμφων.

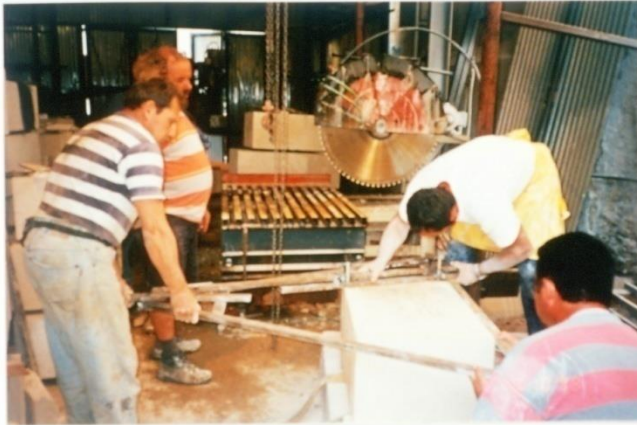
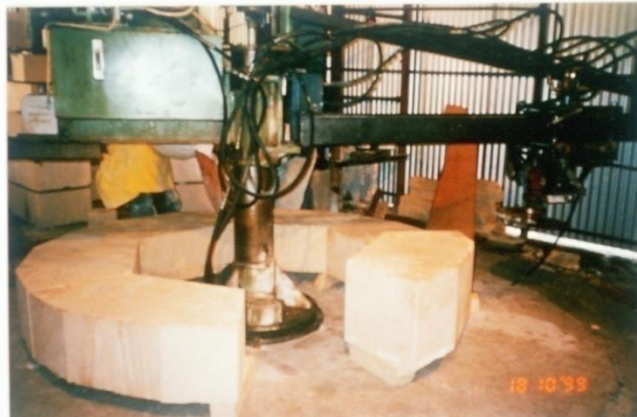
ΟΙ ΔΟΜΟΙ ΕΡΧΟΝΤΑΙ ΑΠΟ ΤΟ ΛΑΤΟΜΕΙΟ ΣΕ ΚΑΝΟΝΙΚΑ ΠΑΡΑΛΛΗΛΕΠΙΠΕΔΑ ΣΧΗΜΑΤΑ  
ΣΤΟ ΕΡΓΟΣΤΑΣΙΟ ΧΑΡΑΖΟΝΤΑΙ ΟΙ ΕΠΙΘΥΜΗΤΕΣ ΔΙΑΣΤΑΣΕΙΣ (ΜΕ ΤΗ ΒΟΗΘΕΙΑ ΕΙΔΙΚΑ  
ΚΑΤΑΣΚΕΥΑΣΜΕΝΩΝ ΔΙΑΒΗΤΗ ΚΑΙ ΚΑΝΟΝΑ) ΚΑΙ ΚΑΤ'ΑΡΧΗΝ ΚΟΒΟΝΤΑΙ ΣΤΟΝ ΤΡΟΧΟ  
ΟΙ ΠΛΑΙΝΕΣ ΑΚΜΕΙΣ ΚΑΙ ΟΙ ΑΠΟΤΜΗΣΕΙΣ ΤΟΥ ΚΥΚΛΑΙΚΟΥ ΤΟΞΟΥ

- It was essential that the stone was cut at millimeter precision and tested again for its fitting to its place.
- There have been some clever transformations to ordinary tools so that they adopt to curve cutting.

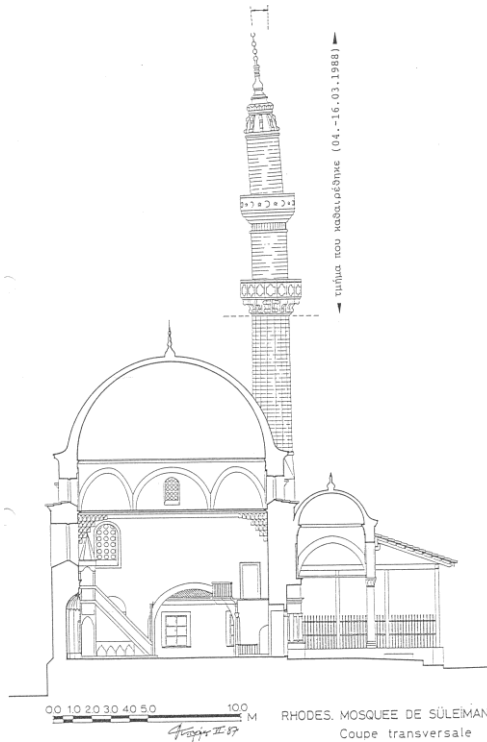
ΑΠΟΚΑΤΑΣΤΑΣΗ ΜΙΝΑΡΕ ΤΖΑΜΙΟΥ ΣΟΥΛΕΙΜΑΝ Μεσαιωνική πόλη Ρόδου  
ΑΠΟΤΥΠΩΣΗ ΥΠΑΡΧΟΝΤΟΣ Σ Γ Κ Α Ρ Ε Ι Α Τ Ο Μ Η  
Θέσμος ΤΕΙΤΡΟΥΛΗΣ, Αρχιτέκτονας-Αναστήλωτης τηλ.01/3242014

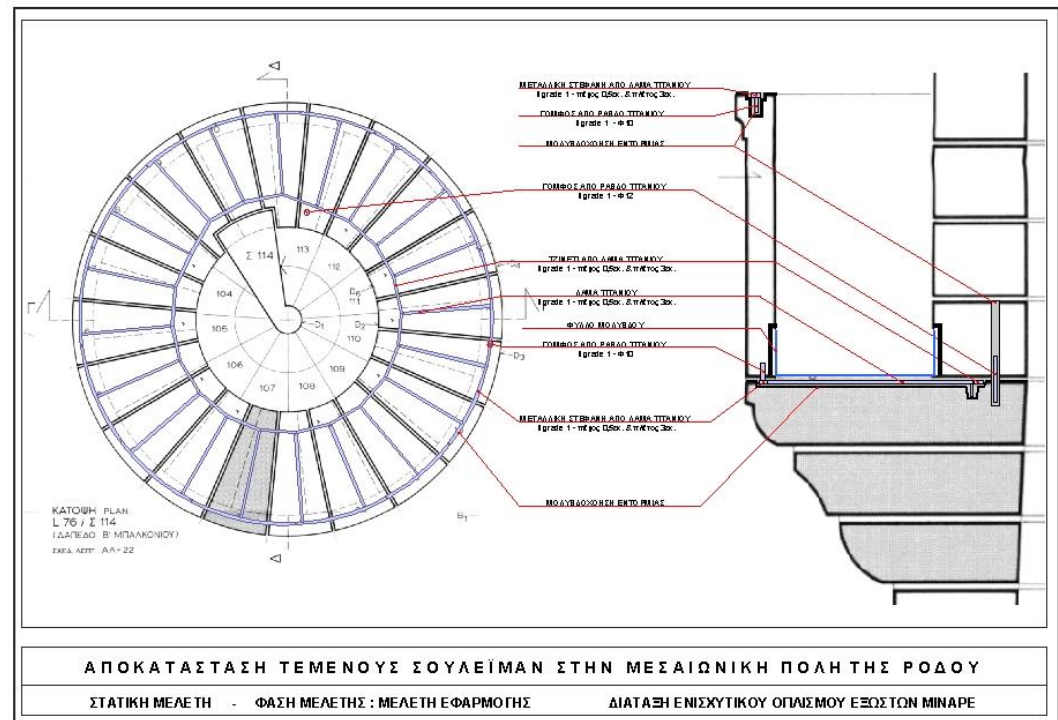
We gave geometric rules for the stonecutting of the complex staircase

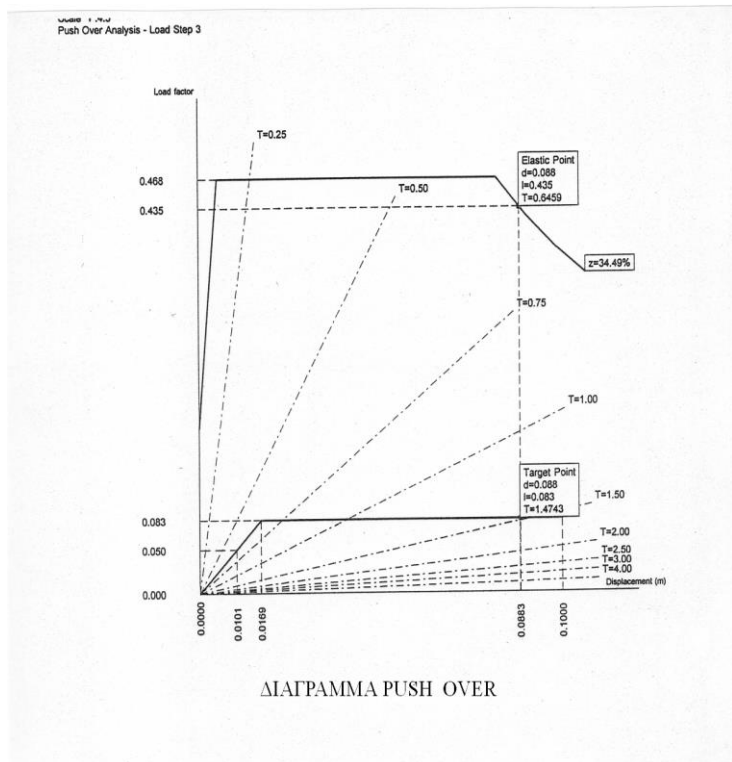
# Structural investigations 2002

- Our static analysis was made using the push-over method. The minaret was initially considered tenacious on his cylindrical-conical base (which constitutes the critical cross-section) and it was simulated by 24 successive rings that correspond to its real geometry and masses.
- The picture of the minarets behavior to increasing lateral forces that resulted from the analysis is that we will have at first an elastic branch up to a force corresponding to 0,083G and then cracking will begin. At the target point of displacement we will have inert areas between the joints and non-flexible shortenings at an altitude of 3.0 m. approximately from the base of minaret.
- At this point, the secant natural period of the minaret would be 1.47 sec., while the elastic one would be 0.57, and the assumption of the seismic force would correspond to 9% of the weight.

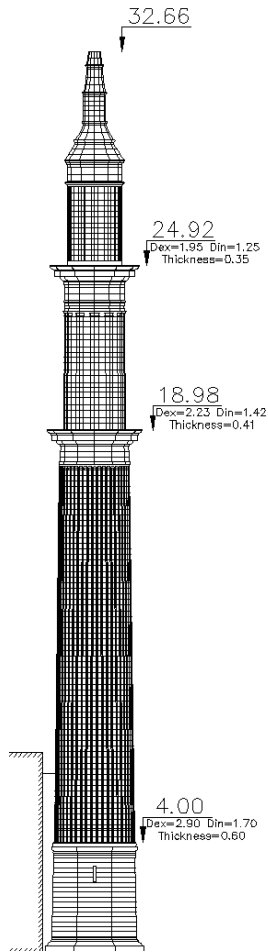
# Basic geometry data

- The minaret, has two balconies and a total height of 32.66 m, without the barbed tip. The octagonal base has a height of 3.44 m. At this height, where the cylindrical-conical part begins, the external diameter is 2.9 m, the inner diameter is 1.69 m and the thickness of the “ring” is 0.605 m.
- The first balcony of the minaret is 14.96m high from the beginning of cylindrical-conical part. At this point the external diameter is 2.23 m, the internal diameter is 1.42 m and the thickness of the “ring” is 0.405 m.
- The second balcony is 5.95 m above the first one. At this point the external diameter is 1.95 m, the internal diameter is 1.25 m and the thickness of the “ring” is 0,35 m.

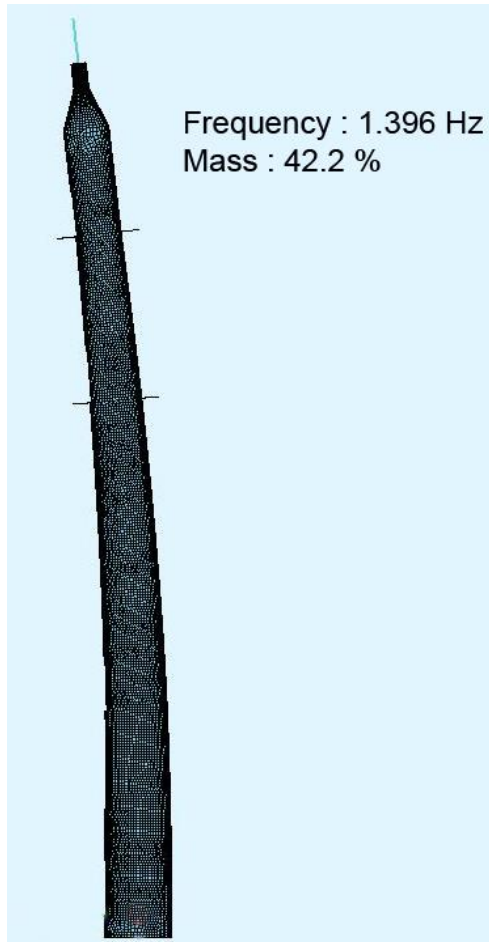
# Structural analysis

- For earthquake  $\epsilon=0,40$
- Maximum compressive stress -5.50 Mpa
- Maximum tensile stress +2.12 Mpa
- Measurements at the bottom level of the free section of the minaret, for a combination that includes seismic charge as well.

- Maximum displacement at the top 106,5 mm
- For the stonemasonry we consider maximum allowable Compressive stress  $f_{wc} \approx 3,5$  MPa and
- Tensile stress  $f_{wt} \approx 0,35$  MPa

- In this case the maximum displacement at the top would be  $0,25/0,40 \times 106,5 \approx 66,6$  mm
- In order to have tensile stress below the maximum allowable we should experience an earthquake  $\epsilon = 0,35/2,12 \times 0,40 \approx \mathbf{0,07}$

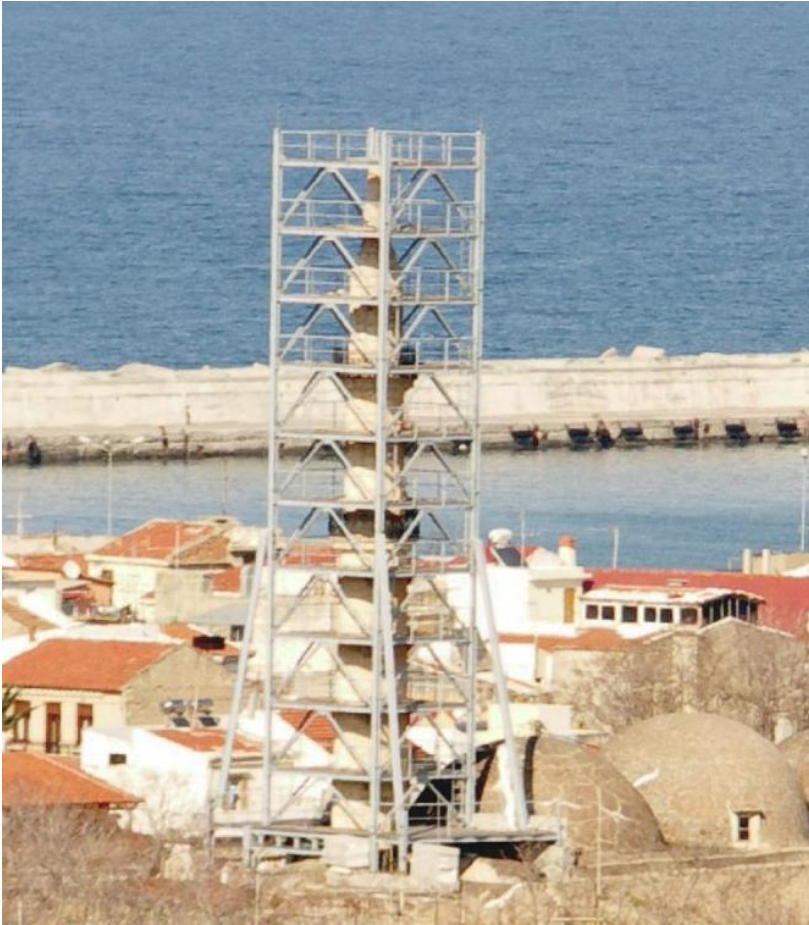
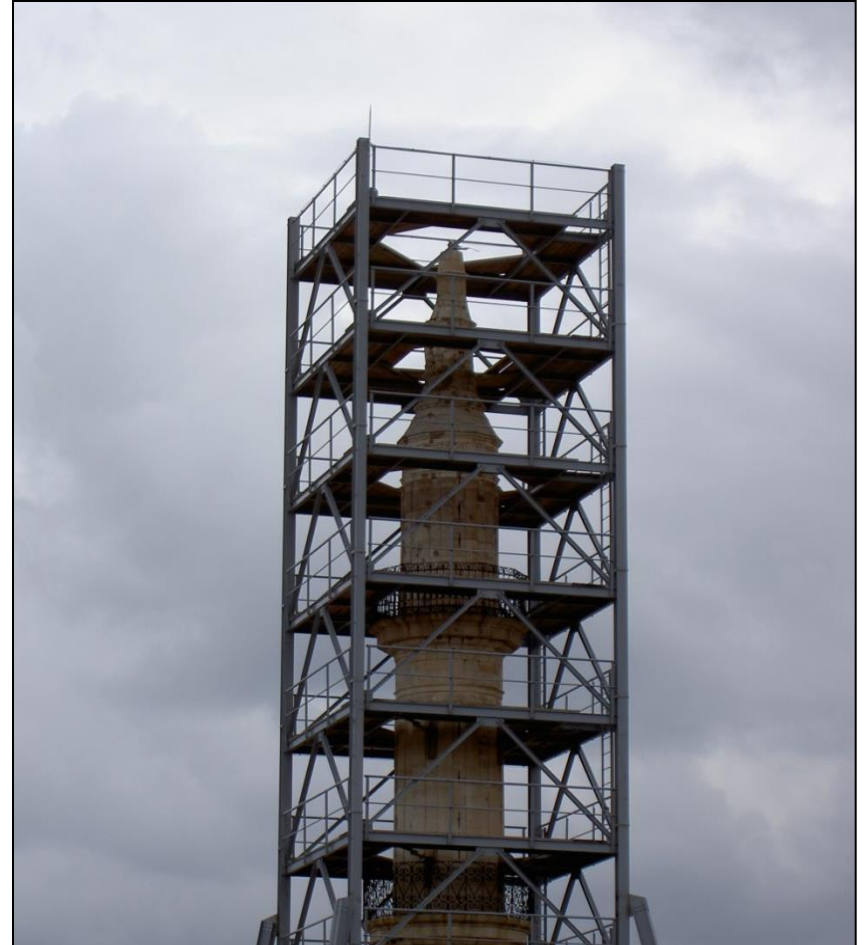
The scaffolding after construction was used for the study of the monument, and the urgent works of demolition of dangerous parts

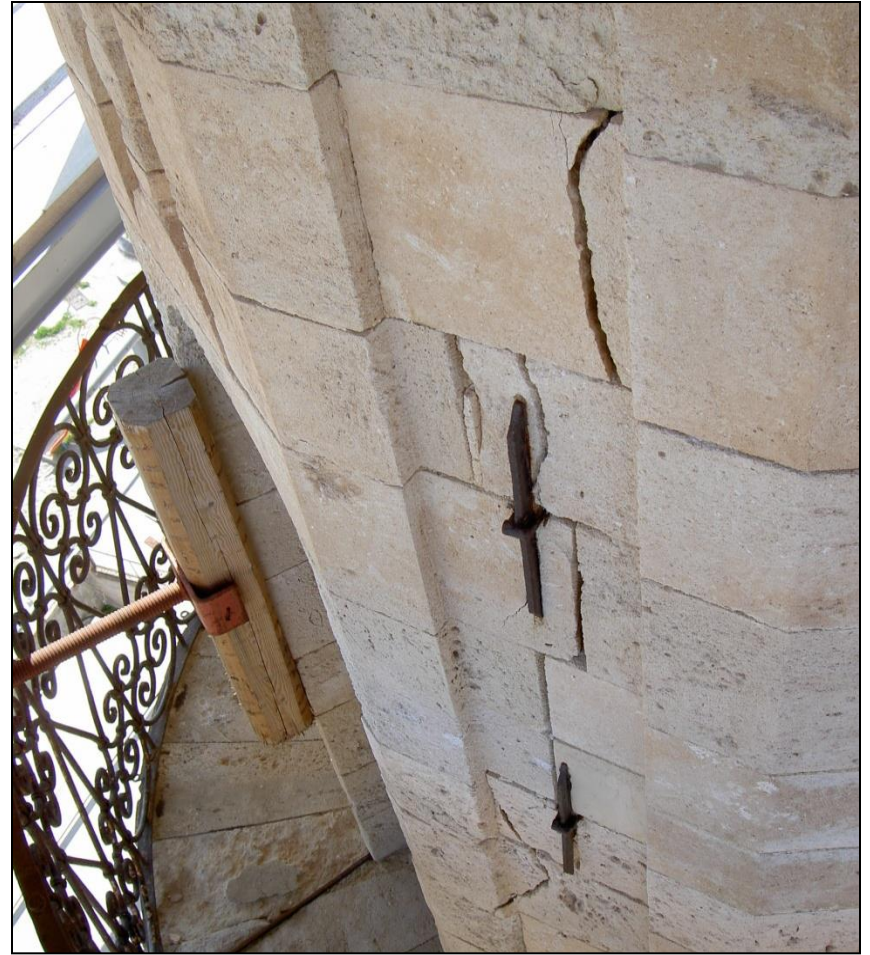
# Staircase and iron reinforcement fastenings

Damage is limited mainly in the upper parts after the first balcony

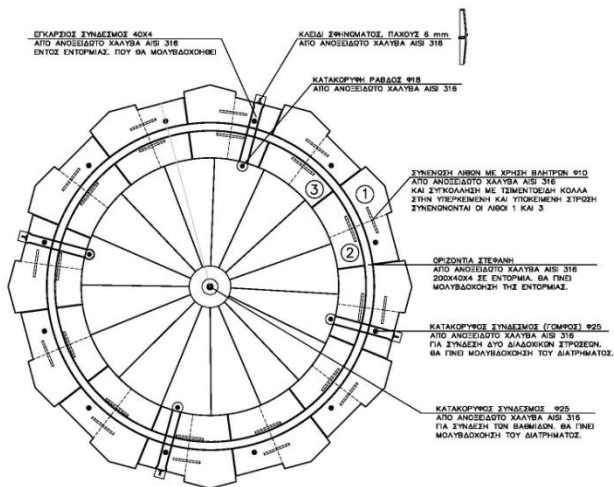
ΤΡΟΠΟΣ ΣΥΝΔΕΣΗΣ ΚΑΘ'ΥΨΟΣ ΥΠΑΡΧΟΝΤΩΝ ΚΑΙ ΝΕΩΝ ΛΙΘΩΝ  
ΣΤΙΣ ΣΕΙΡΕΣ 1 ΕΩΣ 13 ΚΑΙ ΒΡ ΕΩΣ ΑΨ

ΤΡΟΠΟΣ ΣΥΝΔΕΣΗΣ ΛΙΘΩΝ ΓΙΑ ΤΗ ΔΗΜΙΟΥΡΓΙΑ  
ΕΝΙΑΙΟΥ ΜΠΑΤΙΚΟΥ ΛΙΘΟΥ (ΙΣΟΠΑΧΟΥ ΜΕ ΤΟΝ ΤΟΙΧΟ)

ΟΙ ΛΙΘΟΙ 1ΚΑΙ 4 ΜΕΤΑ ΑΠΟ ΠΡΩΤΗΝ ΣΥΝΤΗΡΗΣΗ, ΘΑ ΕΙΝΑΙ ΑΠΟ ΤΟ ΥΠΑΡΧΟΝ ΥΛΙΚΟ  
ΟΙ ΛΙΘΟΙ 2 ΚΑΙ 3 ΣΤΟ ΥΠΑΡΧΟΝ ΥΛΙΚΟ, ΑΠΟΤΕΛΟΥΝΤΑΙ ΑΠΟ ΠΕΡΙΣΣΟΤΕΡΑ  
ΤΟΥ ΕΝΟΣ ΤΕΜΑΧΙΑ ΚΑΙ ΠΡΟΤΕΙΝΕΤΑΙ ΝΑ ΓΙΝΟΥΝ ΑΠΟ ΝΕΟ ΥΛΙΚΟ  
ΠΟΥ ΘΑ ΕΝΟΠΙΟΘΕΙ ΜΕ ΤΟΝ ΠΑΡΑΠΑΝΩ ΛΙΘΟ 1 Ή 4

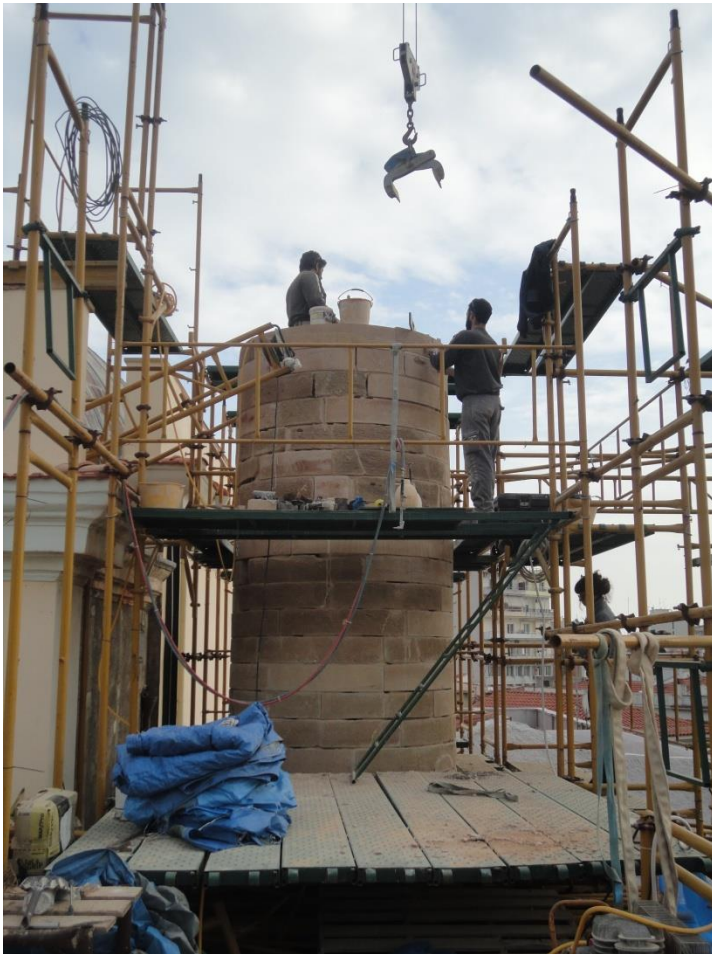
It was under dimensioned, it has fallen twice and we decided to strengthen it

Thicker stones at the base and  
“loose” steel bars to help keep  
geometrical integrity in a  
strong motion

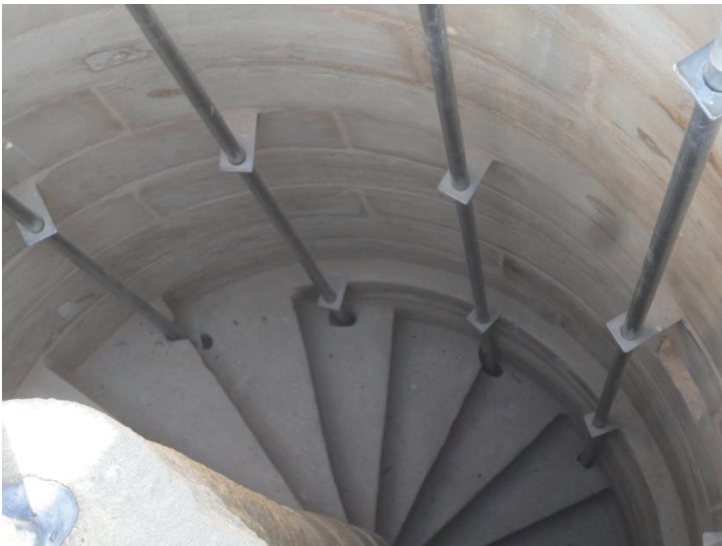
ΛΕΠΤΟΜΕΡΕΙΑ ΚΑΤΑΣΚΕΥΗΣ ΤΥΠΙΚΗΣ ΚΑΤΑΚΟΡΥΦΗΣ ΣΤΡΩΣΗΣ  
ΜΕ ΟΡΙΖΟΝΤΙΟΥΣ ΣΥΝΔΕΣΜΟΥΣ (ΤΣΙΝΕΤΙΑ), ΚΑΤΑΚΟΡΥΦΟΥΣ ΣΥΝΔΕΣΜΟΥΣ (ΓΟΜΦΟΥΣ)  
ΚΑΙ ΚΑΤΑΚΟΡΥΦΕΣ ΔΙΑΜΗΚΕΙΣ ΡΑΒΔΟΥΣ ΕΣΩΤΕΡΙΚΑ

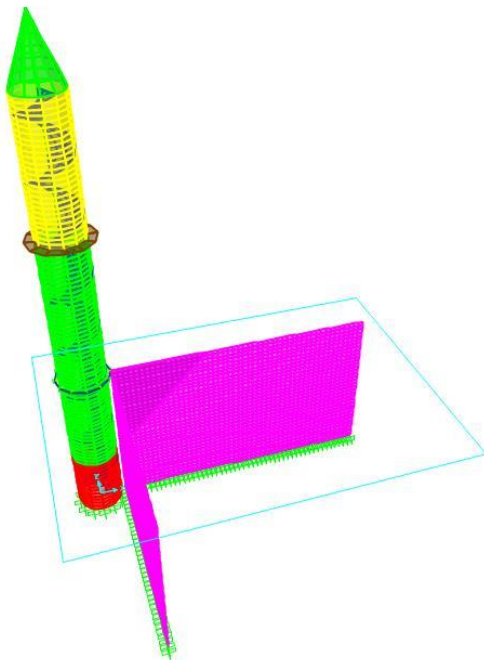
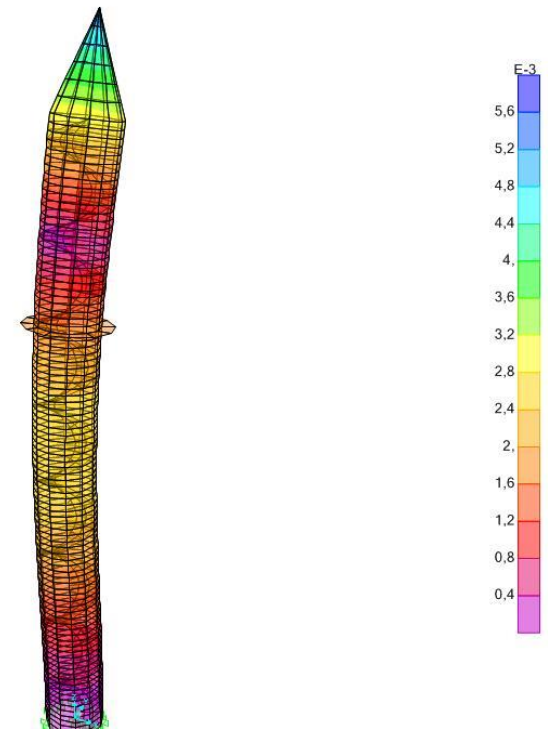
## Modeling as elastic system using FE

# Structural analysis

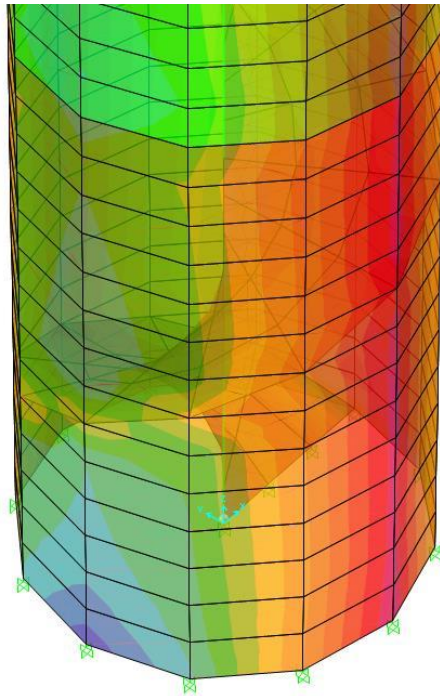
# Moment is double from the strength capacity

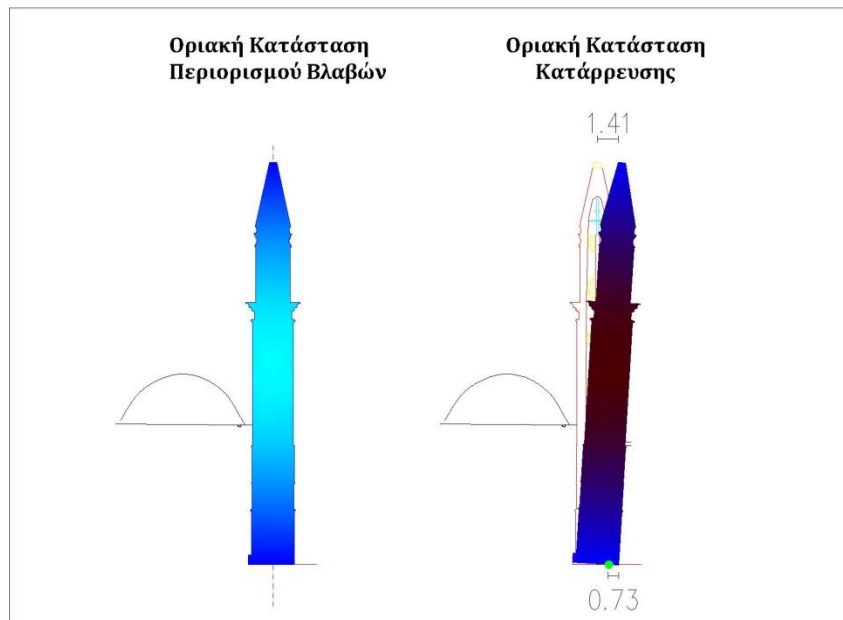
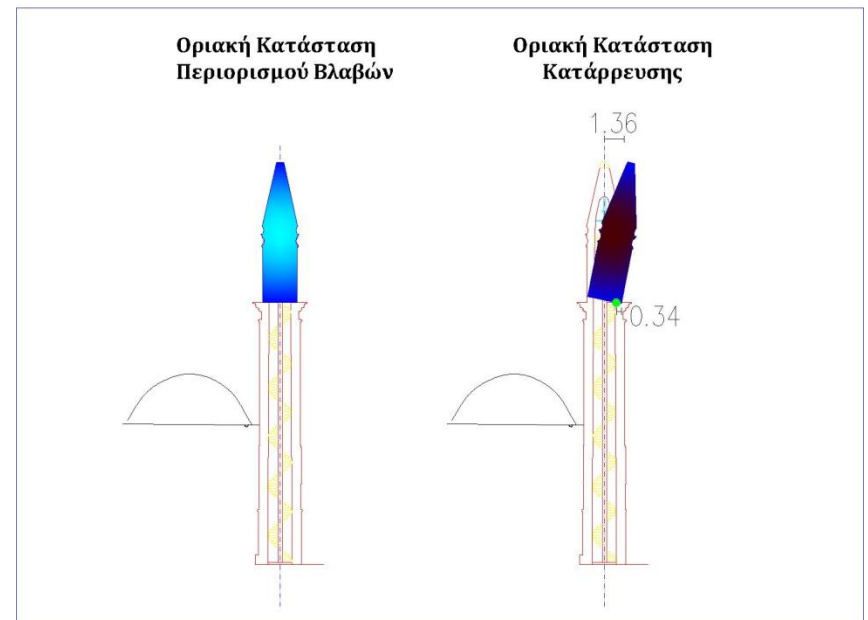
The minaret seems to be safe on the two examined overturning mechanisms as a rigid body (kinematic analysis)
